SUBJECT: COBRA 139XLR MODIFICATIONS

PROBLEM A. TR-36/R153 Crystal drift due to overheating.

PROBLEM B. PCB cracking or breaking due to rough handling.

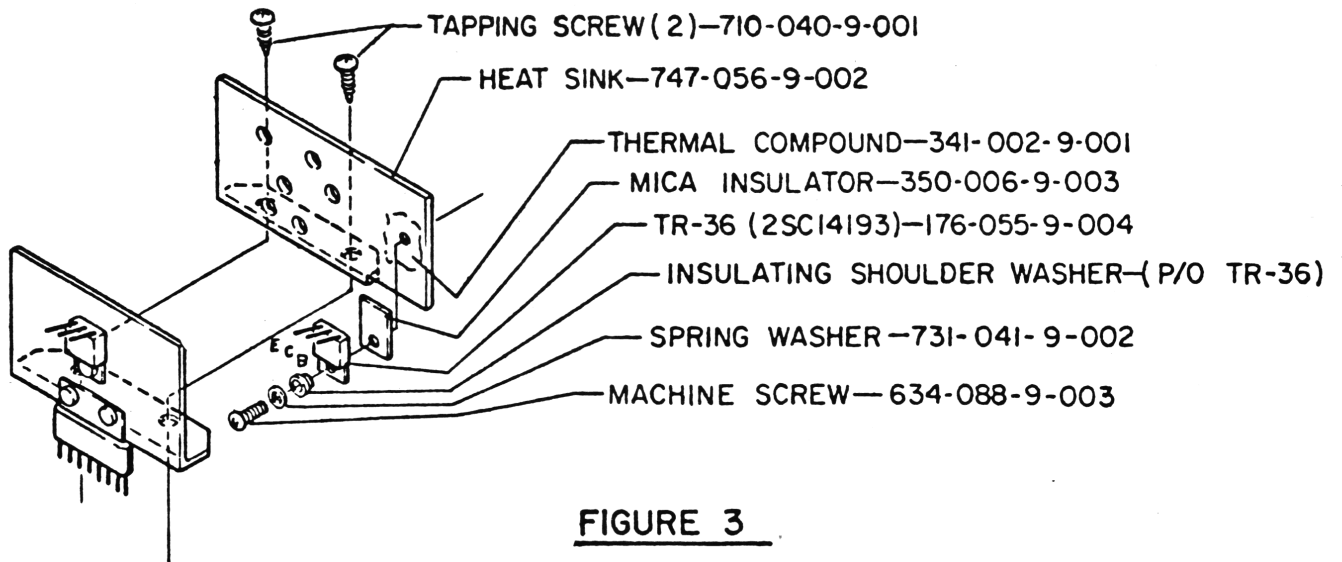
FIGURE 3

After radio has been on for a period of time, high temperature generated by TR-36 and R-153 overheats the SSB crystals thereby causing excessive transmitter or receiver drift on SSB operation.

7. Unsolder and remove TR-36 from present location.
8. Mount TR-36 on auxiliary heat sink (747-056-9-002 supplied with this mod. kit) using the existing hardware and insulators (Fit.3). Apply thermal compound (341-002-9-001) on both sides of mica insulator before installation. When installing insulated shoulder washer, make sure that the smaller end seats in transistor hole. When tightening transistor mounting screw be careful not to damage insulated shoulder washer.
