HINT'S AND KINK'S

COBRA 140GTL/142GTL/148GTL

SUBJECT: Regulator IC shorting out in the 140GTL, 142GTL and 148GTL. IC-5 (140 & 142GTL), IC-4 (148GTL).

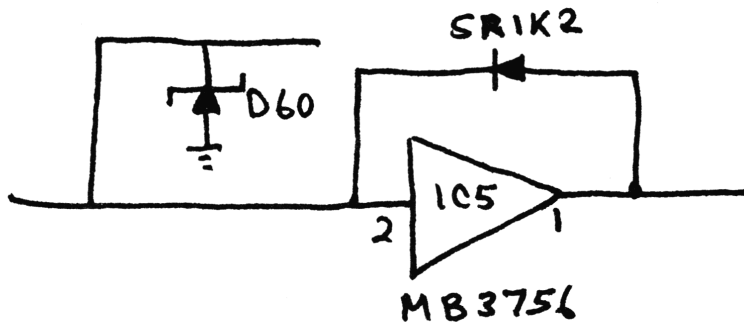
SYMPTOM: High AM power output (10 watts) and low modulation weak of no receive.

SOLUTION: Replace IC-5 (IC-4 for 148GTL) and change D-60 (D-44 for 148GTL) to a 18.2 volt zener diode. Add a SR1k2 diode from pin 1 to pin 2 of IC-5 (IC-4 for 148GTL). (Use Diode) Remove from D-60/44.

NOTE: This modification should be done on all radios In-Warranty repair. If IC-5 (IC-4) checks good, only make diode changes.
