BROWNING MARK IV TRANSMITTER

SERVICE HINTS

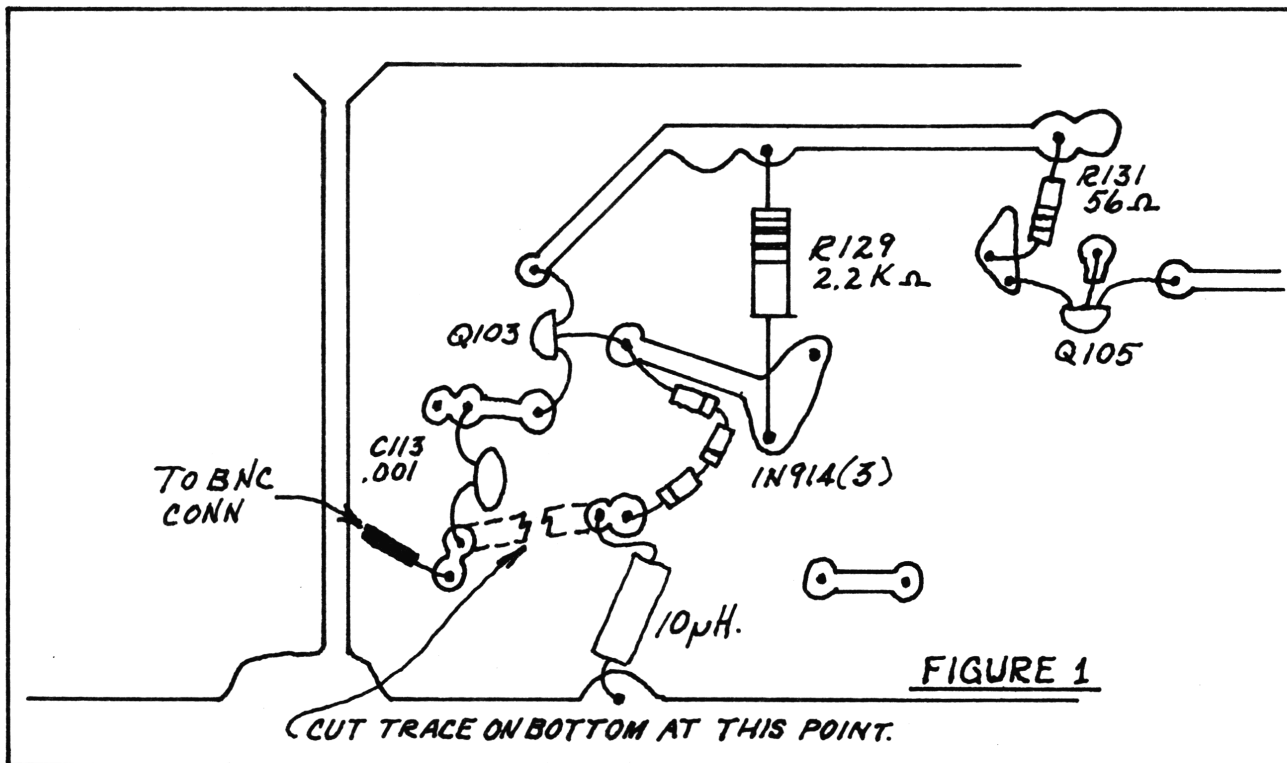
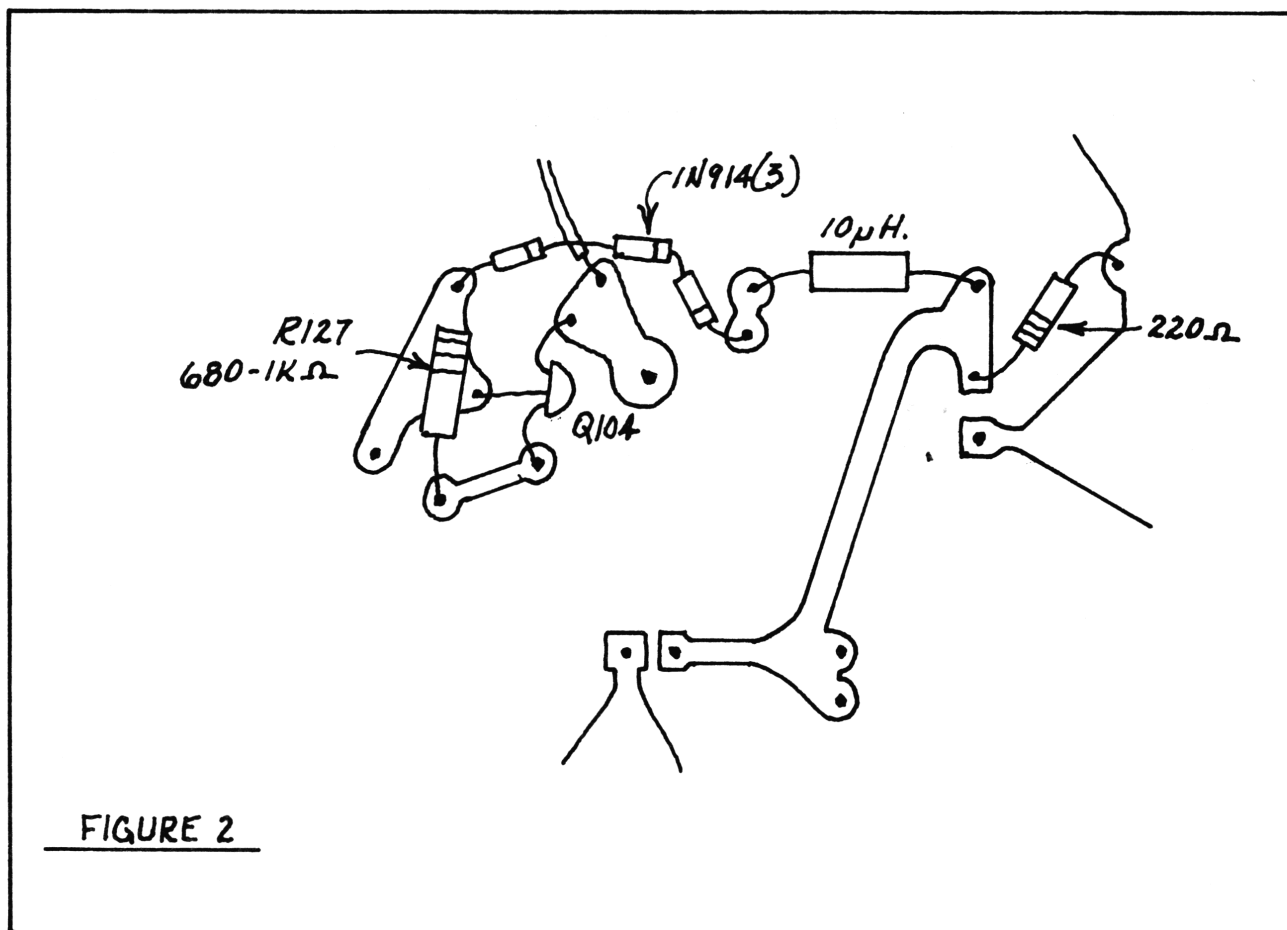
SYMPTOM:

The Channel Number display is blank and the transmit relay will not key. The reset "low limit" LED comes on but there is no channel display.

3. In those units where the symptom is still present after the foregoing changes have been made, proceed with the following:
 - a. The color stripes on Q102, Q103 and Q104, MPS6514 transistors should be checked. If the 2nd or middle stripe is yellow, it should be replaced. The transistors with the yellow stripe have lower gain and can be employed elsewhere in the unit, but cannot be used for Q102, Q103, or Q104.

1. In the synthesizer circuit (PLL section) C121 should be 10pF N750 and C123 39pF N750. The early 23 channel models employed NPO's. Also R101 and R102 should be changed to 330 ohms, and a 1 megohm resistor should be added from the base of Q101 to ground.

2. The changes noted in paragraph 1 have been incorporated in 40 channel units. All units should be checked to insure that the following changes are included. (Refer to Figures 1 and 2)

- a. 3 1N914 diodes and a 10uH choke (or 2 18uH chokes in parallel) in series from the base of Q103 to ground.
 - b. R129 should be 2.2K
 - c. 3 1N914 diodes, a 10uH choke (or 2 18uH chokes in parallel) and a 220 ohm resistor in series from the base of Q104 to ground.

- d. R127 should be 680 to 1000 ohms (normally 1K)
 - e. R131 should be 47 ohms. If a 100 ohm resistor exists, it is acceptable to add another 100 ohm resistor in parallel on the bottom side of the circuit board.

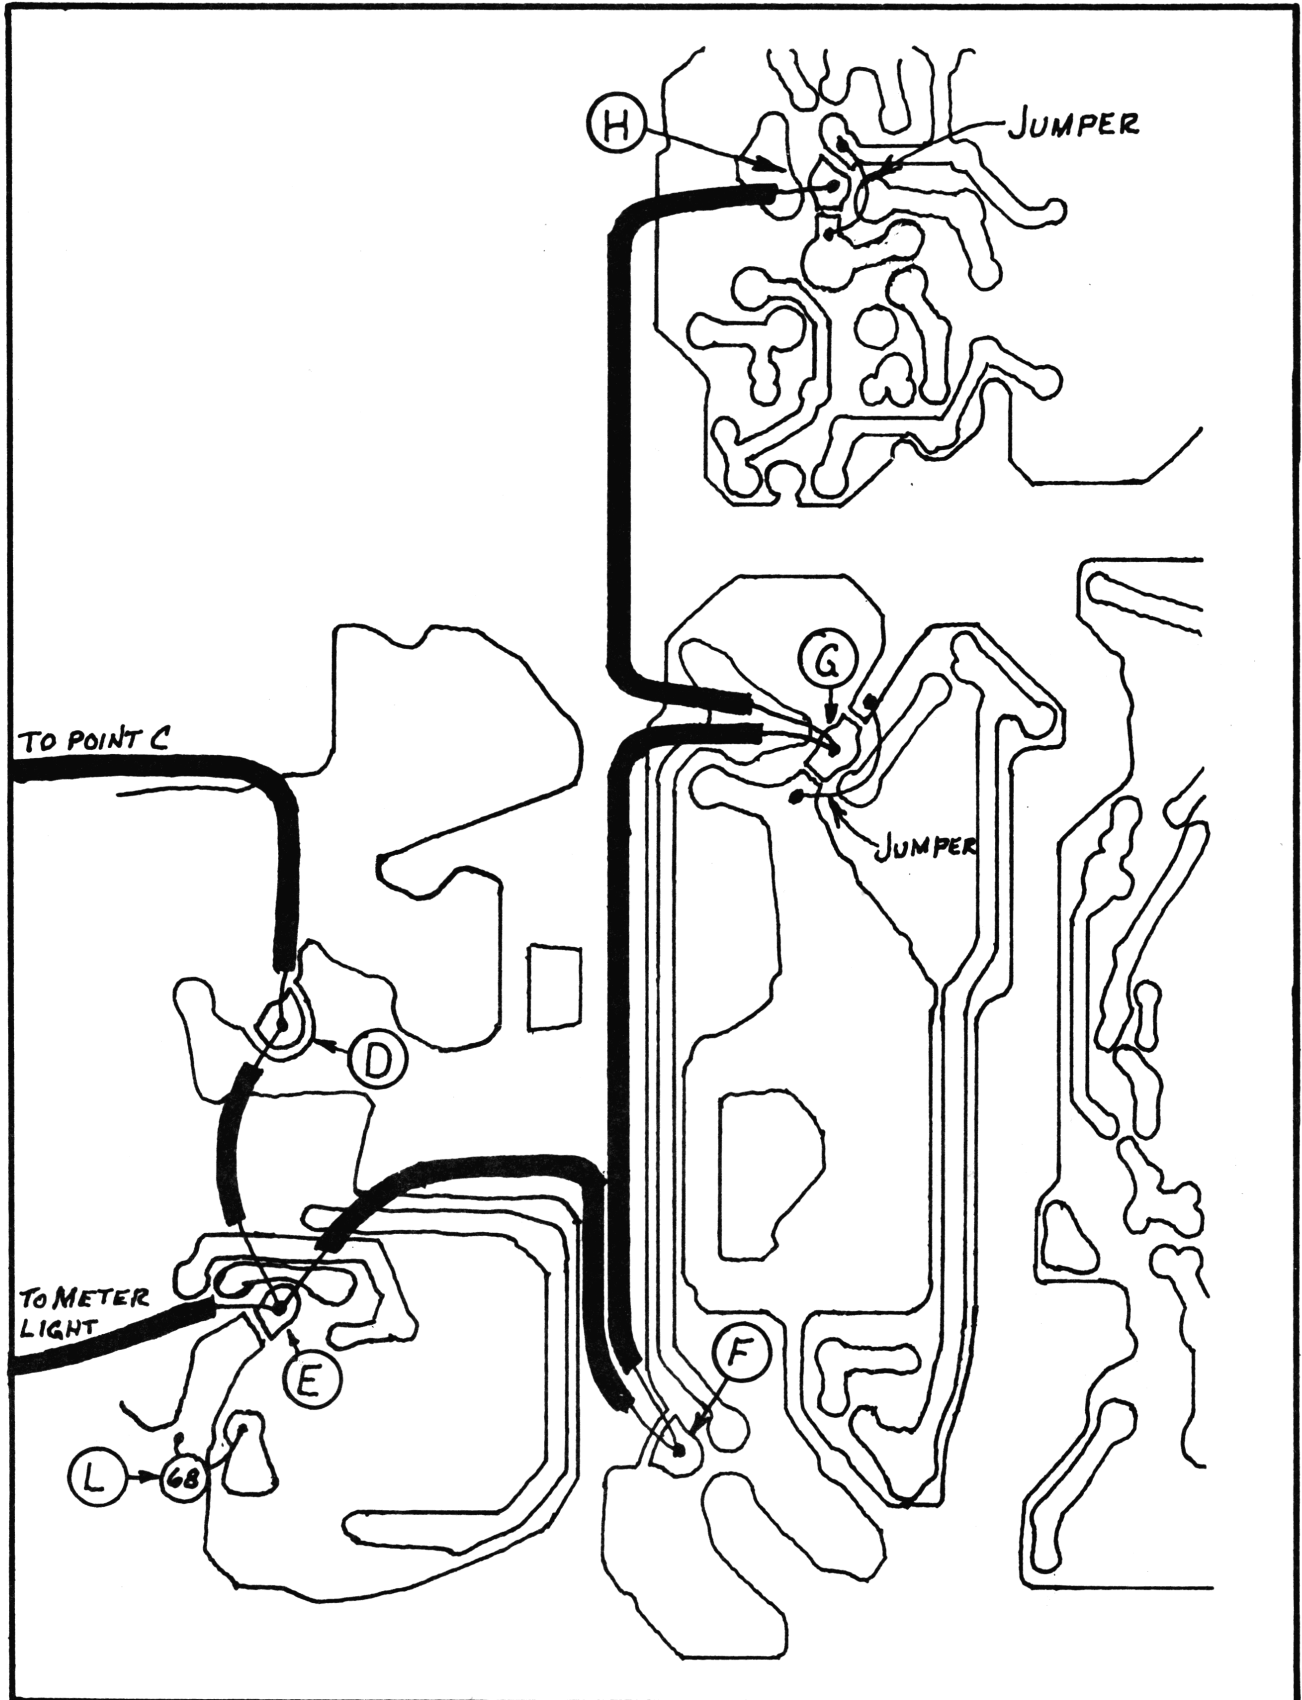
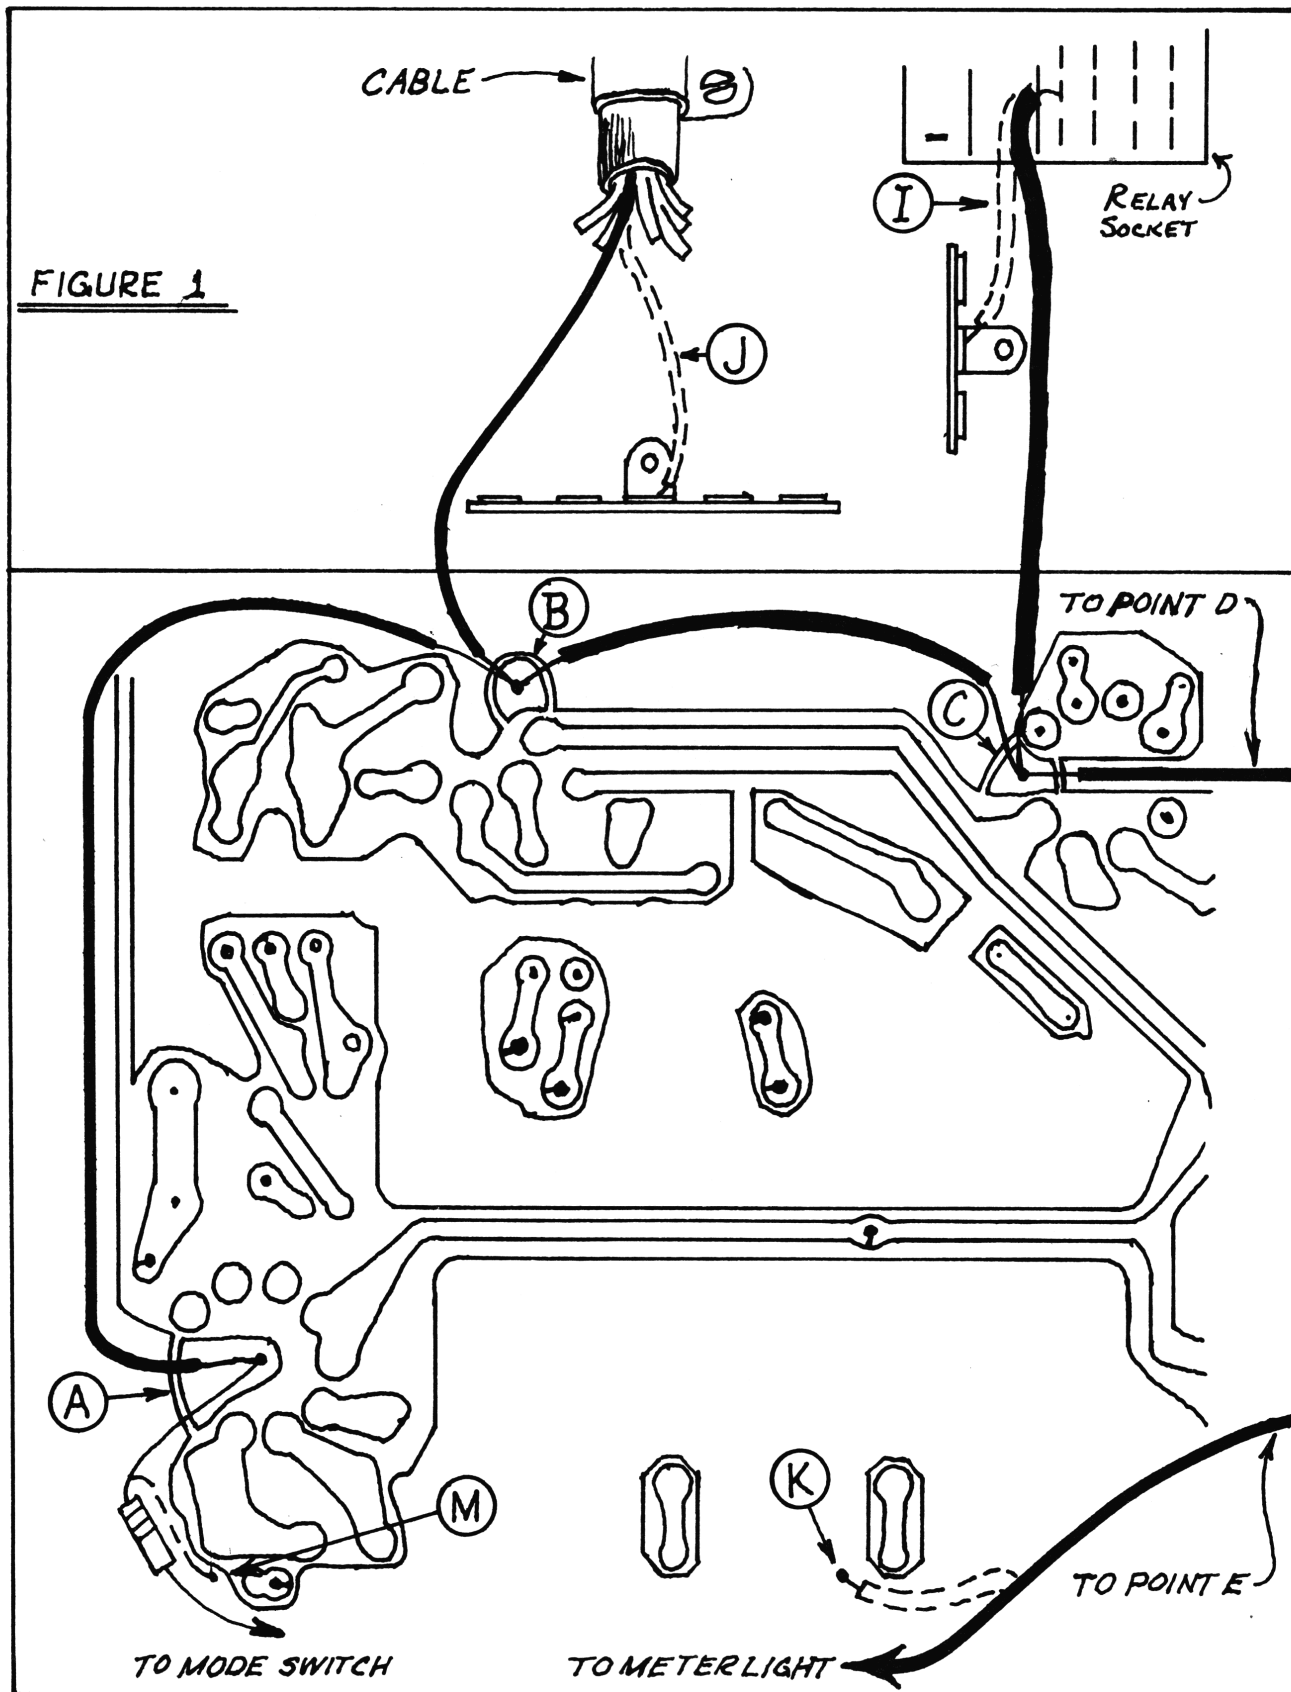
SYMPTOM: Garbled transmit on SSB - especially the upper channels, making it difficult or impossible to clarify it. It has also been described as sounding as if under water.

SOLUTION: Refer to attached diagram.

1. Carefully cut the printed circuit as shown at points A - H - removing the tube filament grounds from the rest of the circuit board ground pattern.
2. Using 18 ga. wire (nothing smaller) connect the filament grounds from points A - H. ROUTE THE WIRES EXACTLY AS SHOWN IN THE DIAGRAM! Any deviation can cause problems such as hum, feedback, etc.

3. Add two small jumper wires at points G and H to connect together the ground pattern on each side of the isolated filament grounds. Keep these jumpers as short as possible without shorting to the tube socket pins.

4. Remove the black wire coming from the meter light socket from where it connects to ground at point K and connect it to the filament ground at point E.

5. Remove C212 (68pF) from its present position on the top side of the circuit board and solder it on the bottom side at point L.
6. Remove the end of the 10 ohm resistor that connects to ground at point M and extending its length with a buss wire and solder it to filament ground at point A.

7. Remove the short wire from the relay socket to terminal strip ground shown by dotted line at point I. Connect a wire as shown from the relay to filament ground at point C.

9. Disconnect the black wire from the control cable, shown by dotted line at point J, where it connects to ground on a terminal strip, and connect it to filament ground at point B. You may have to lengthen it with a piece of 18 ga. or larger wire.

10. Open the synthesizer cover and on the bottom of the circuit board add a 10pF NPO ceramic disc capacitor from base to collector of Q103. Keep the leads as short as possible.
