SERVICE TIPS

"EXPORT", CYBERNET 02A-PLL AM/FM/SSB CHASSIS

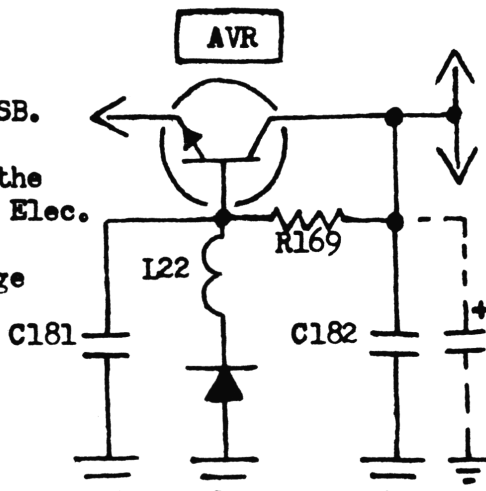
The other big problem is in the AVR, (check your schematics for the right transistor, as is different marking in some chassis..) General Layout below.

Problem: Scratchy TX in SSB.

Note: in most units this is Q36, and a 2SD837 or 2SD1192 is usual transistor.

Cure: Add C184 if not in the circuit. (470Mfd/16V Elec. Capacitor.

If problems persist: change the present Xstr to a 2SD839..

C184; ADD-470Mfd/16VDC, if not in unit. Observe correct polarity!
