Jackson: Audio "Distortion/Blaring"
by R.M.

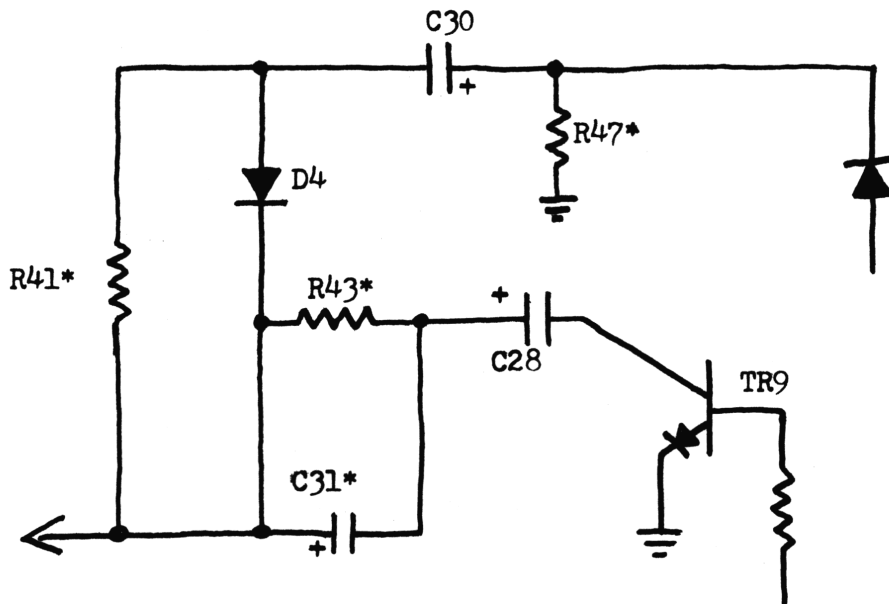
At close range the Jackson has the problem of receive SSB audio being distorted, the RF Gain has very little control over this.

See partial schematic below of components to be changed: (*)

By removing/changing the following parts can be cured:

1. Remove C-31 (0.47Mfd/50VDC electrolytic), no replacement.
2. R-43 (10K); change to 1.5K.
3. R-41 (150K); change to 270K.
4. R-47 (1.5K); change to 3.9K.
