CLEAR CHANNEL CORPORATION

AR-3300 TECHNICAL BULLETIN #1
APR 4, 1986

AR-3300 TECHNICAL BULLETIN #3
APR. 23, 1986

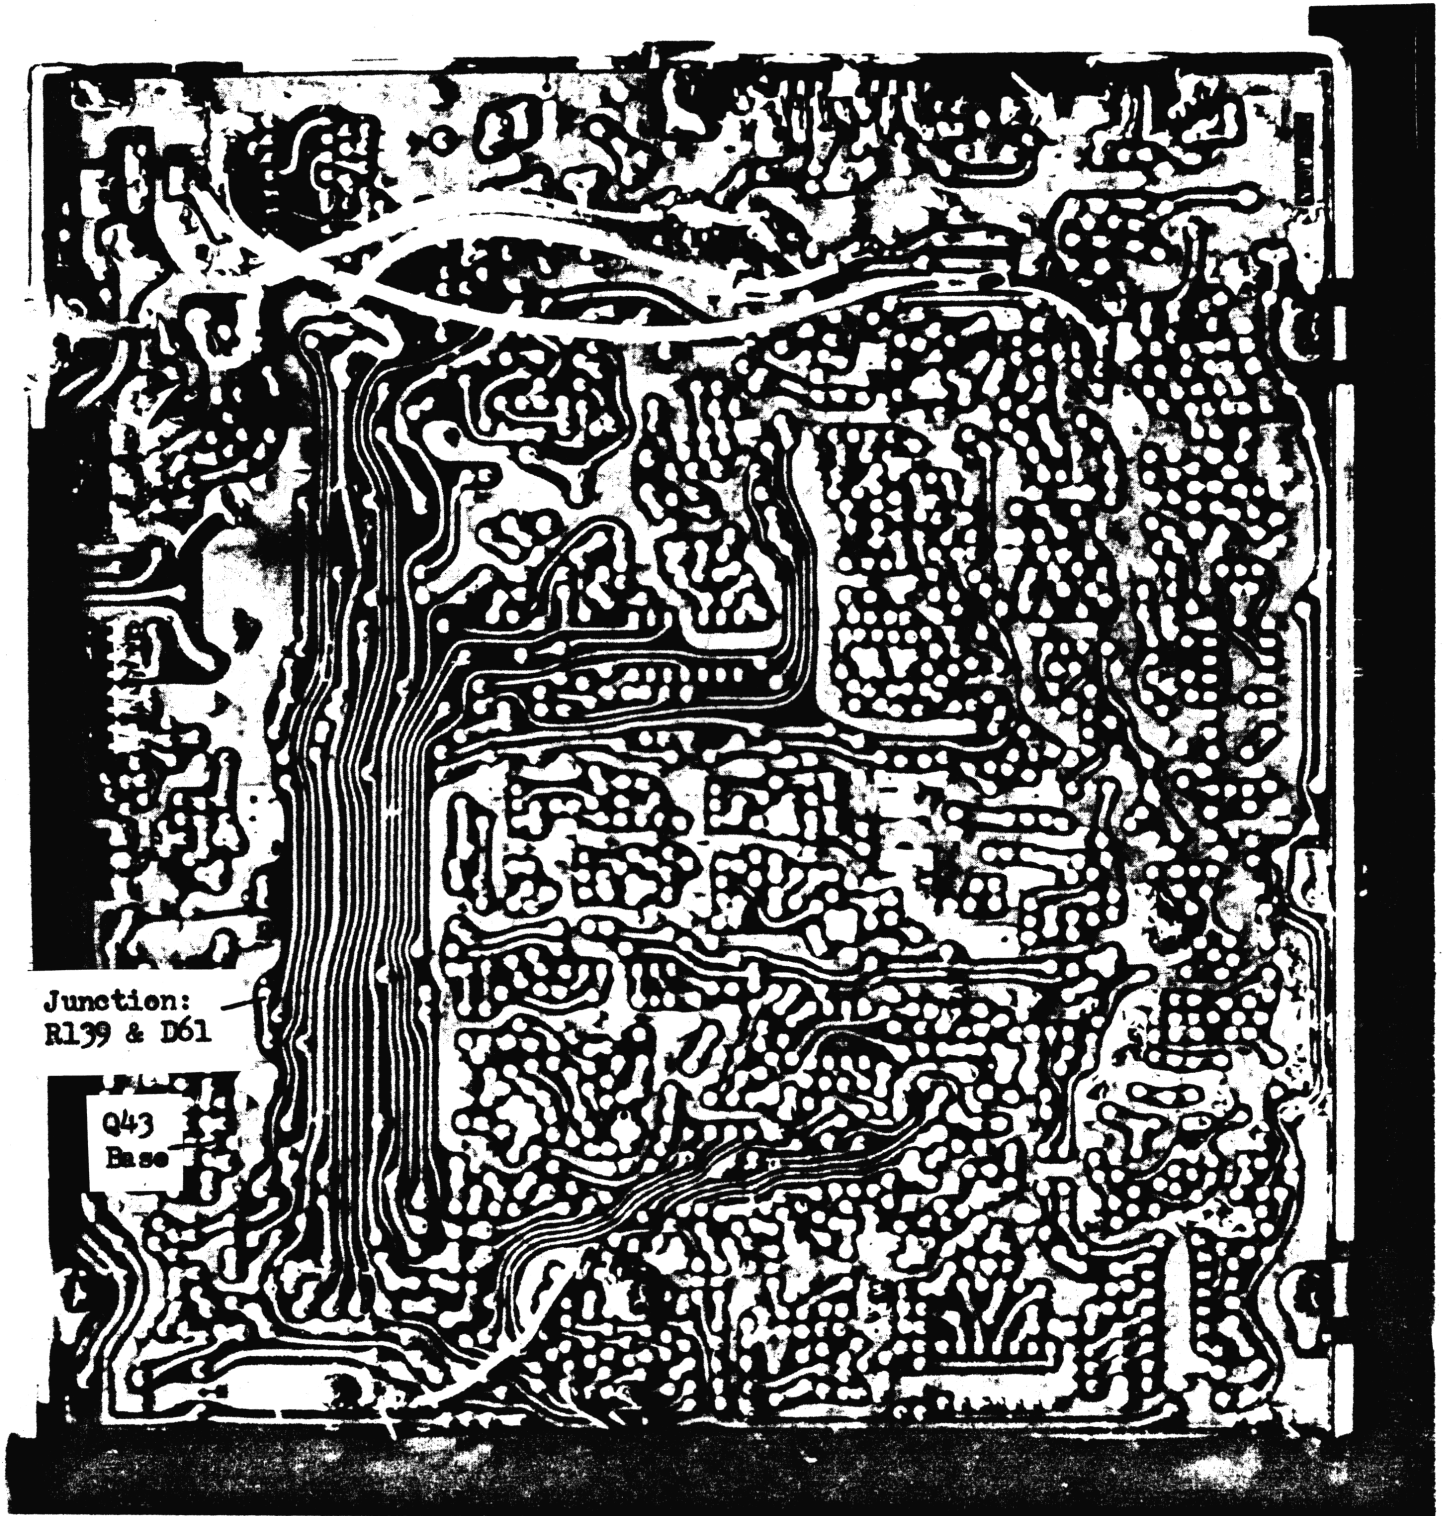
SYMPTOM: First word clipped off.

CAUSE: Modulation amplifier slow turning on (.25 to .5 sec.)

Junction:
R139 & D61

Q43
Base

REMEDY: Change R139 to 4.7 Kohm. Move the cathode of D61 to the base of Q43. Add 220 mfd @ 16V + side to anode D61, - side to ground. (Diode and cap should be placed on bottom {solder side} of PCB for best results.

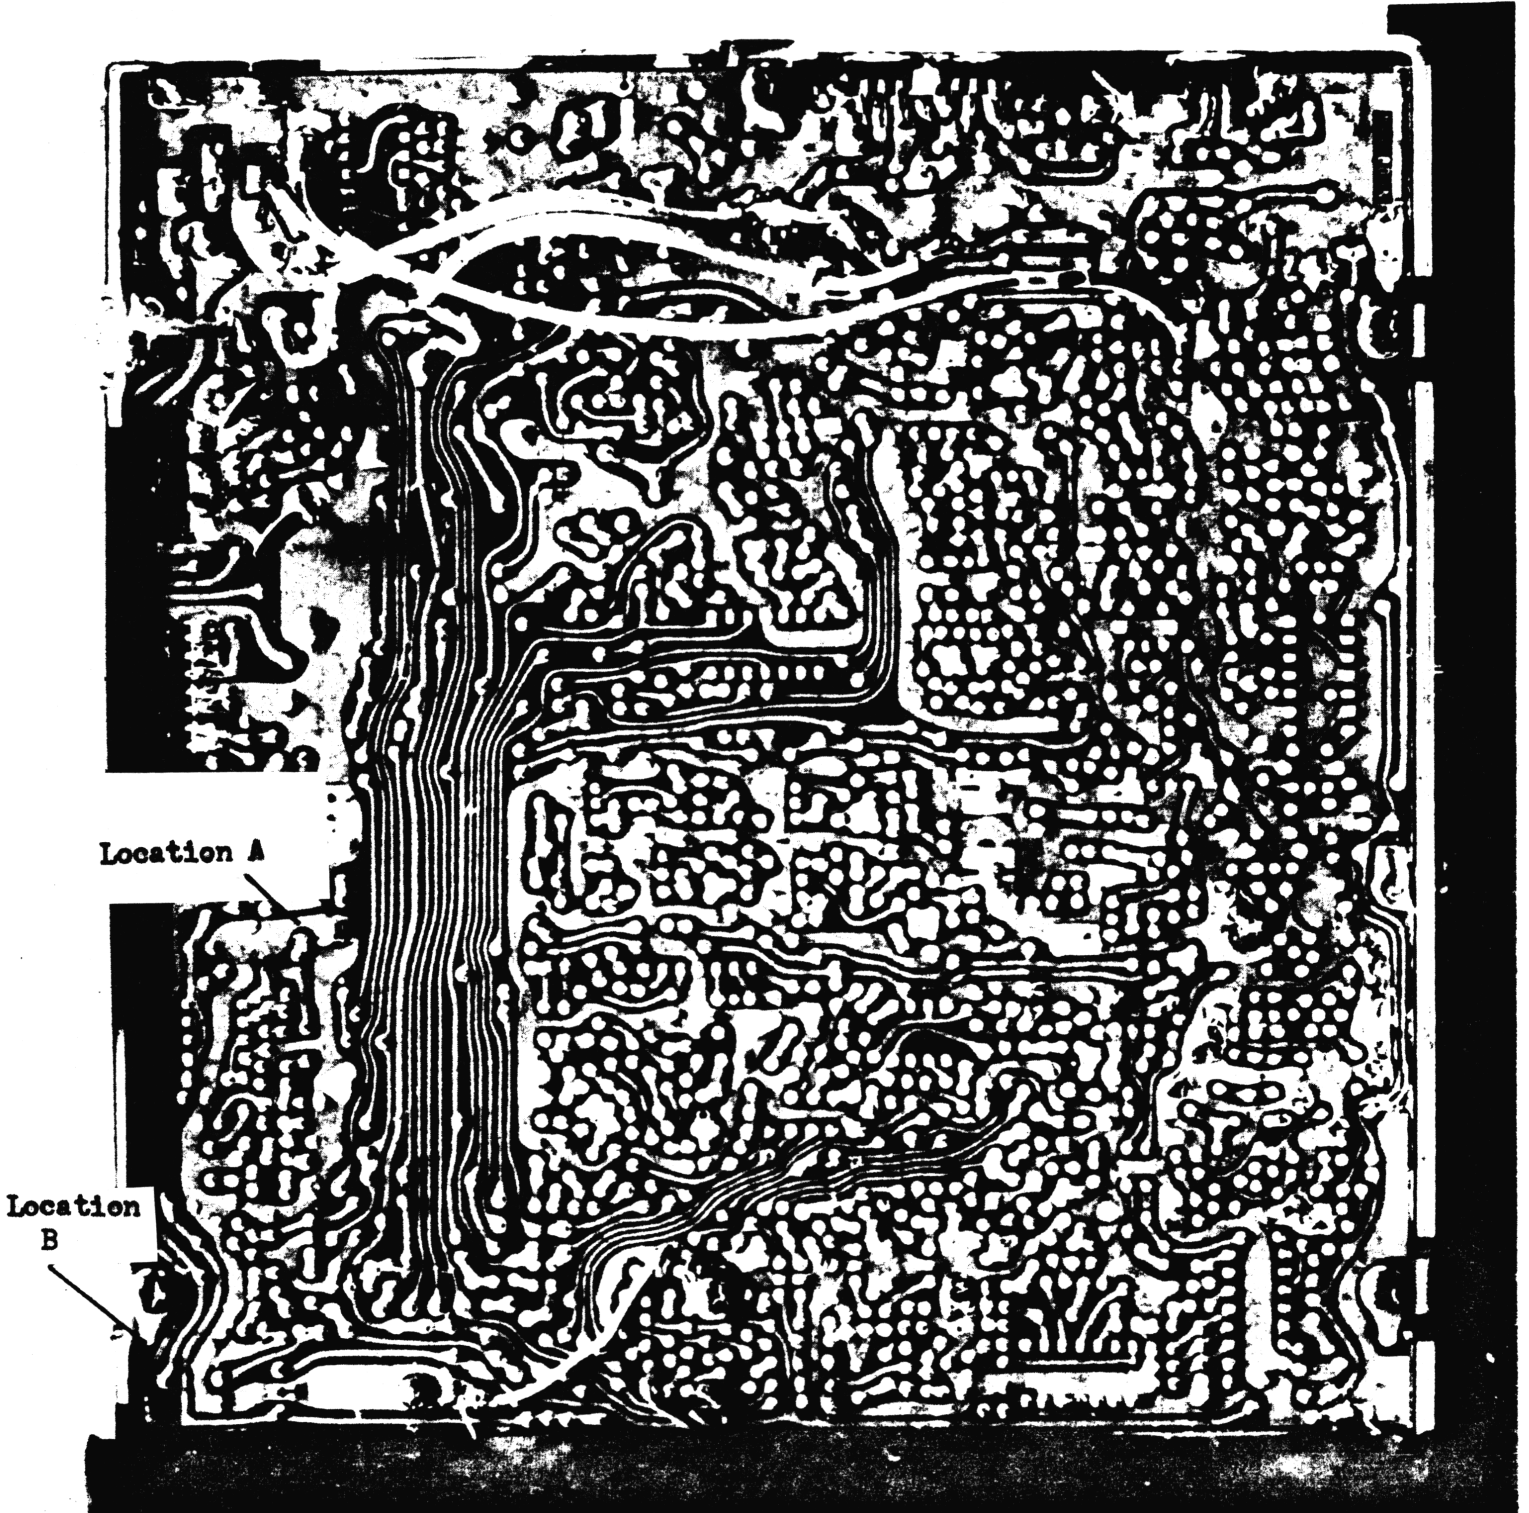
SYMPTOMS: Warble (frequency shift) on SSB. Squeal (audio oscillation) on AM.

CAUSE: Ground loop and by-pass problems on PCB.

REMEDY: Connect open in ground plane on PCB near audio IC8 (see page 2, location A). Connect a .01 capacitor from the spot where ground plane is connected to chassis.

Add by-pass capacitor (.01) at location B (see page 2, location B).

Install by-pass capacitors (.01) between mounting screws of Q28, Q29, Q30 and the RF shield around the power amplifier area. Install a by-pass capacitor from the RF shield and the ground lug of the SO-239 antenna connector.

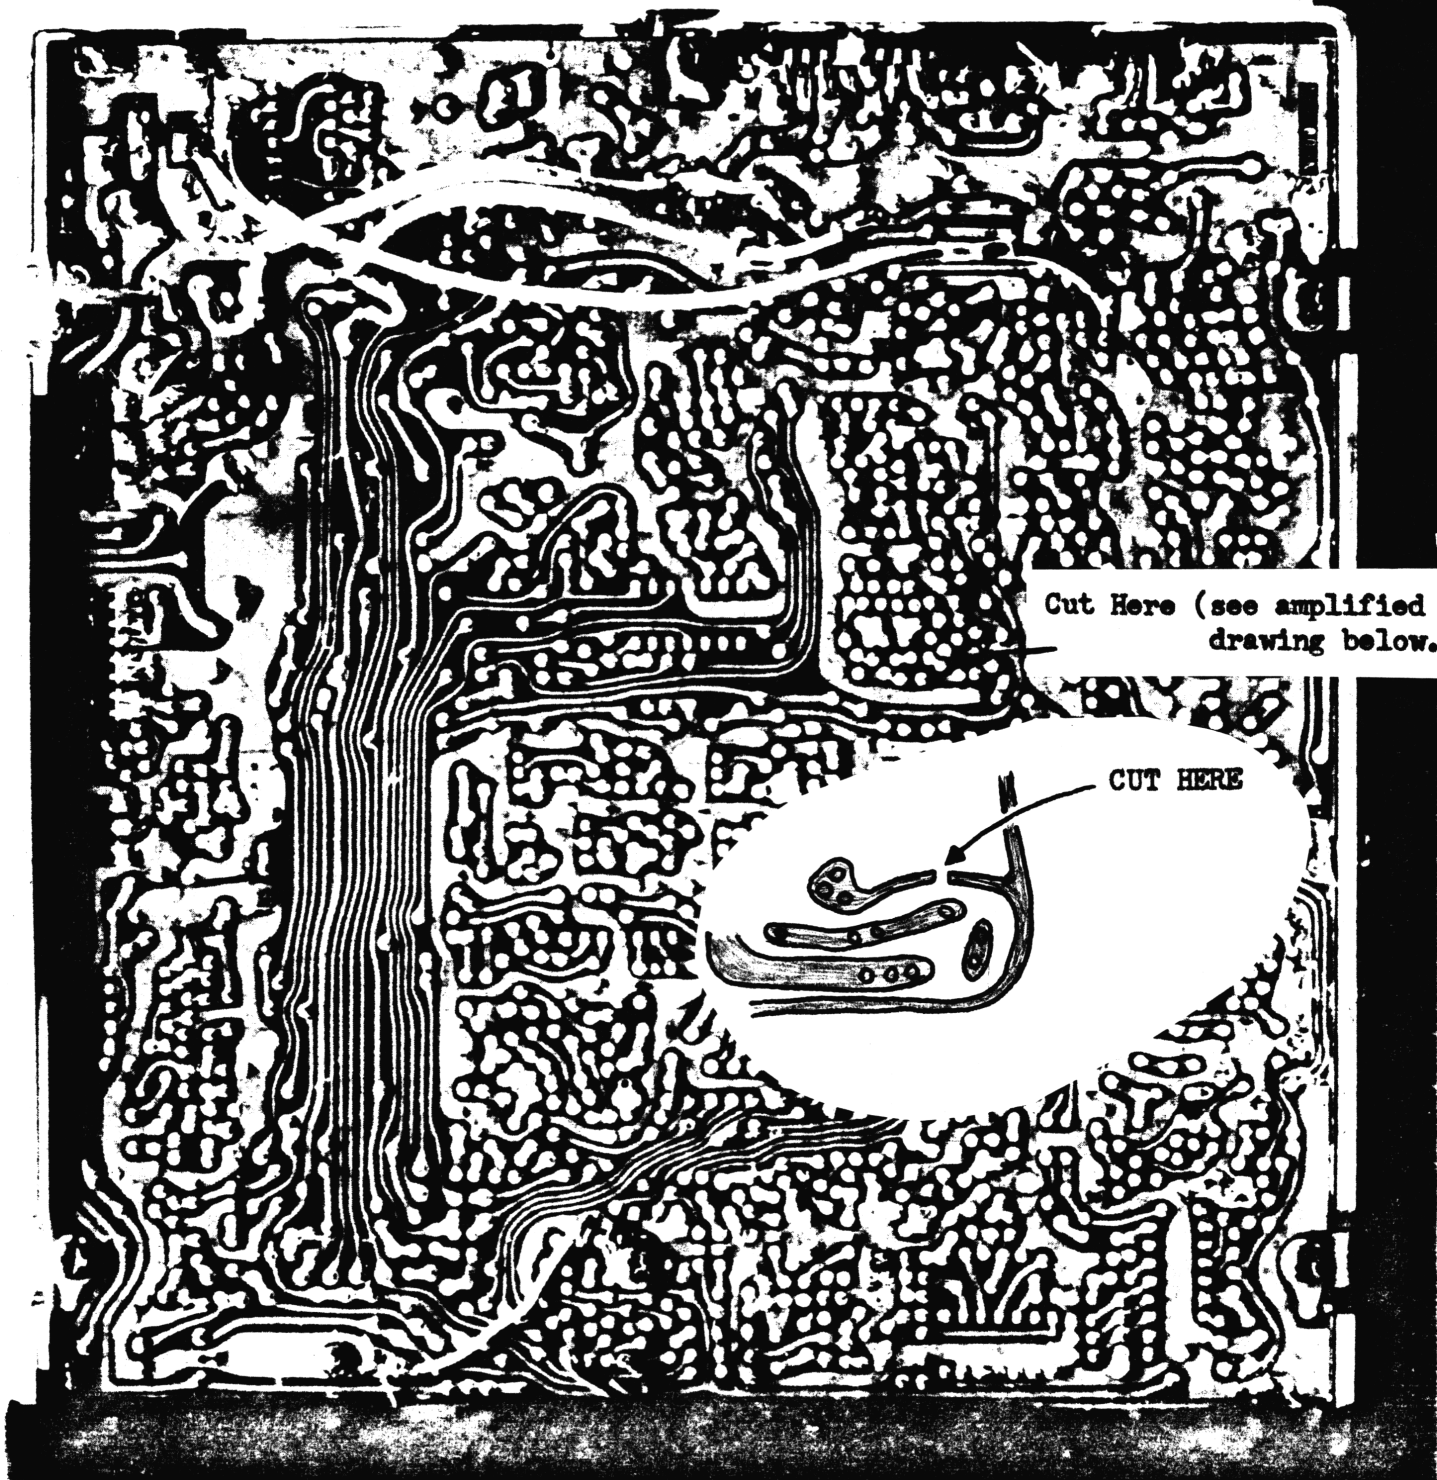
NOISE BLANKER SWITCH

Cut Here (see amplified drawing below..)

CUT HERE

To turn off the noise-blanker cut the trace marked below. A SPST switch can be installed at the cut for a control.
