Cobra 138XLR / 139XLR Technical Bulletin 1208A

COBRA FIELD BULLETIN

SUBJECT: Revision of Bulletin 1208. TR43 & TR44 Burnout.

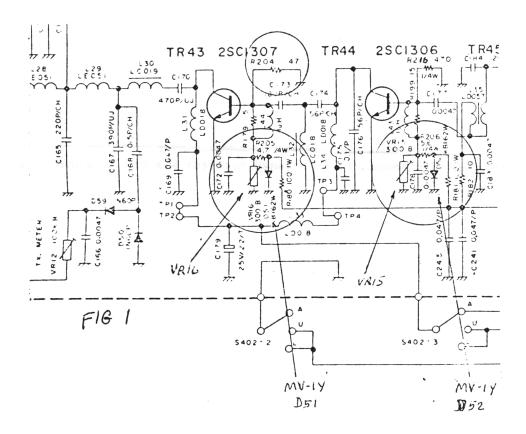
SYMPTOM: No transmit on A.M. or S.S.B. TR43 found defective.

SOLUTION: 1. Remove R204 10 ohm $\frac{1}{2}$ watt resistor.

- 2. Remove C-181 47µf capacitor.
- 3. Remove C-232 180pf capacitor.
- 4. Change R-180 from 56 ohm 2 watt to 100 ohm 1 watt,

Dynascan part number 002-001-6-101.
- 5. Change R205 from 1 ohm $\frac{1}{4}$ watt to 4.7 ohm $\frac{1}{4}$ watt,

Dynascan part number 002-104-5-479.
- 6. Add a 47 ohm $\frac{1}{4}$ W resistor Dynascan part number 002-104-5-470. Schematic symbol to be R204. From base to ground of TR43 final.
- 7. Add a 470 ohm ½ watt resistor Dynascan part number 002-104-5-471 schematic symbol 216 from base to ground of TR-44 driver.
- 8. Change R181 to 100 ohms I watt. Dynascan part number 002-001-6-101.
- 9. Change D51 from a KB162 W diode to a MV-1Y diode Dynascan part number 004-175-9-001. White dot indicates cathode side.
- 10. Change D52 from a KB162W to a MV-ly Dynascan part number 004-175-9-001. White dot indicates cathode side.
- 11. Set driver idle current to 40mA at TP3, TP4 by adjusting control VR15.
- 12. Set final idle current to 15mA at TP1, TP2 by adjusting control VR16.
