TECHNICAL SERVICE BULLETIN 10017

MODEL(S): 19 DX III

DESCRIPTION: Excessive feedback when using PA.

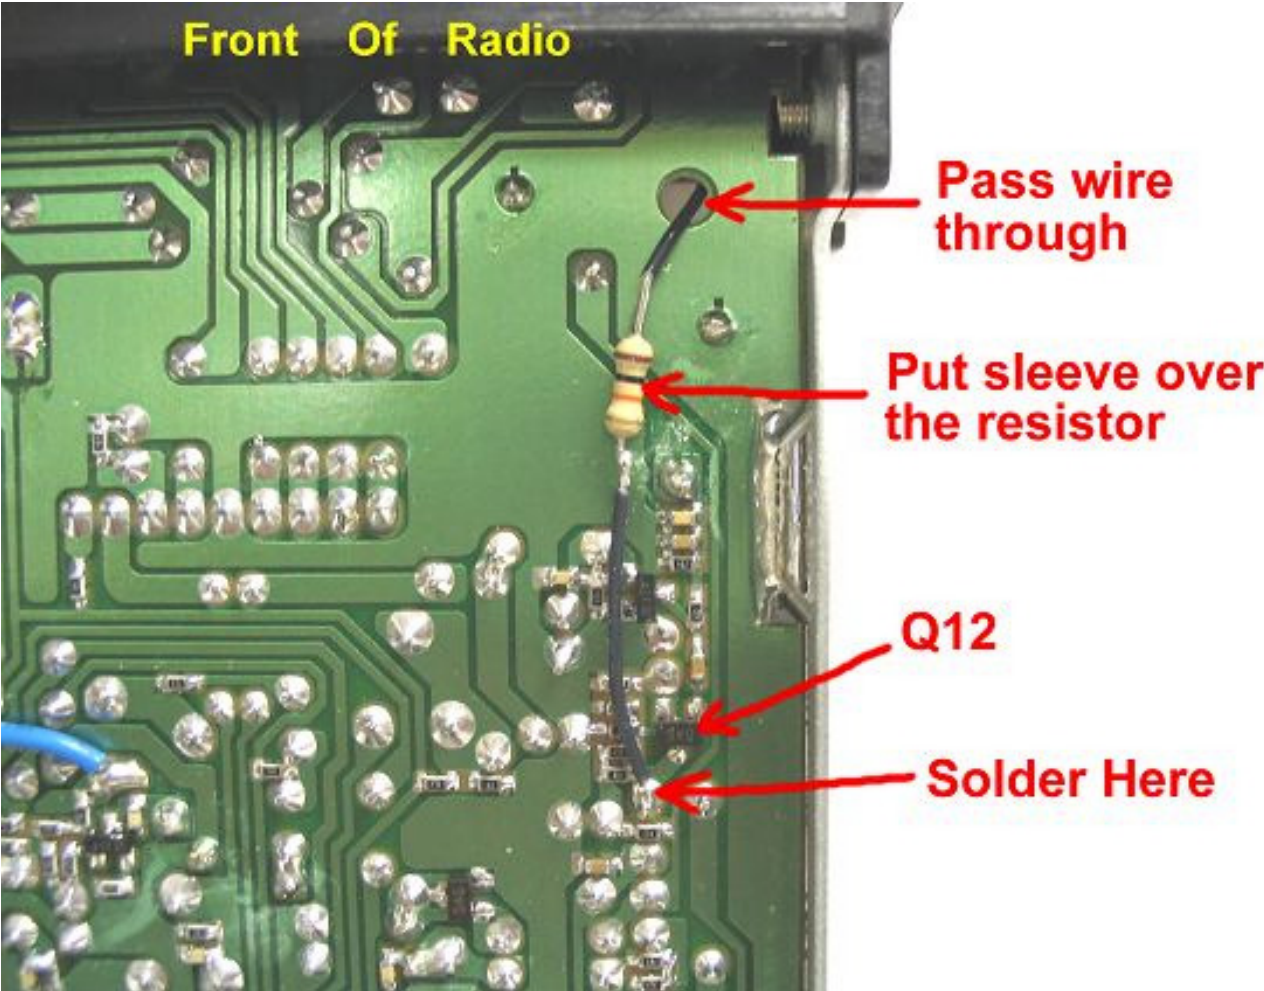
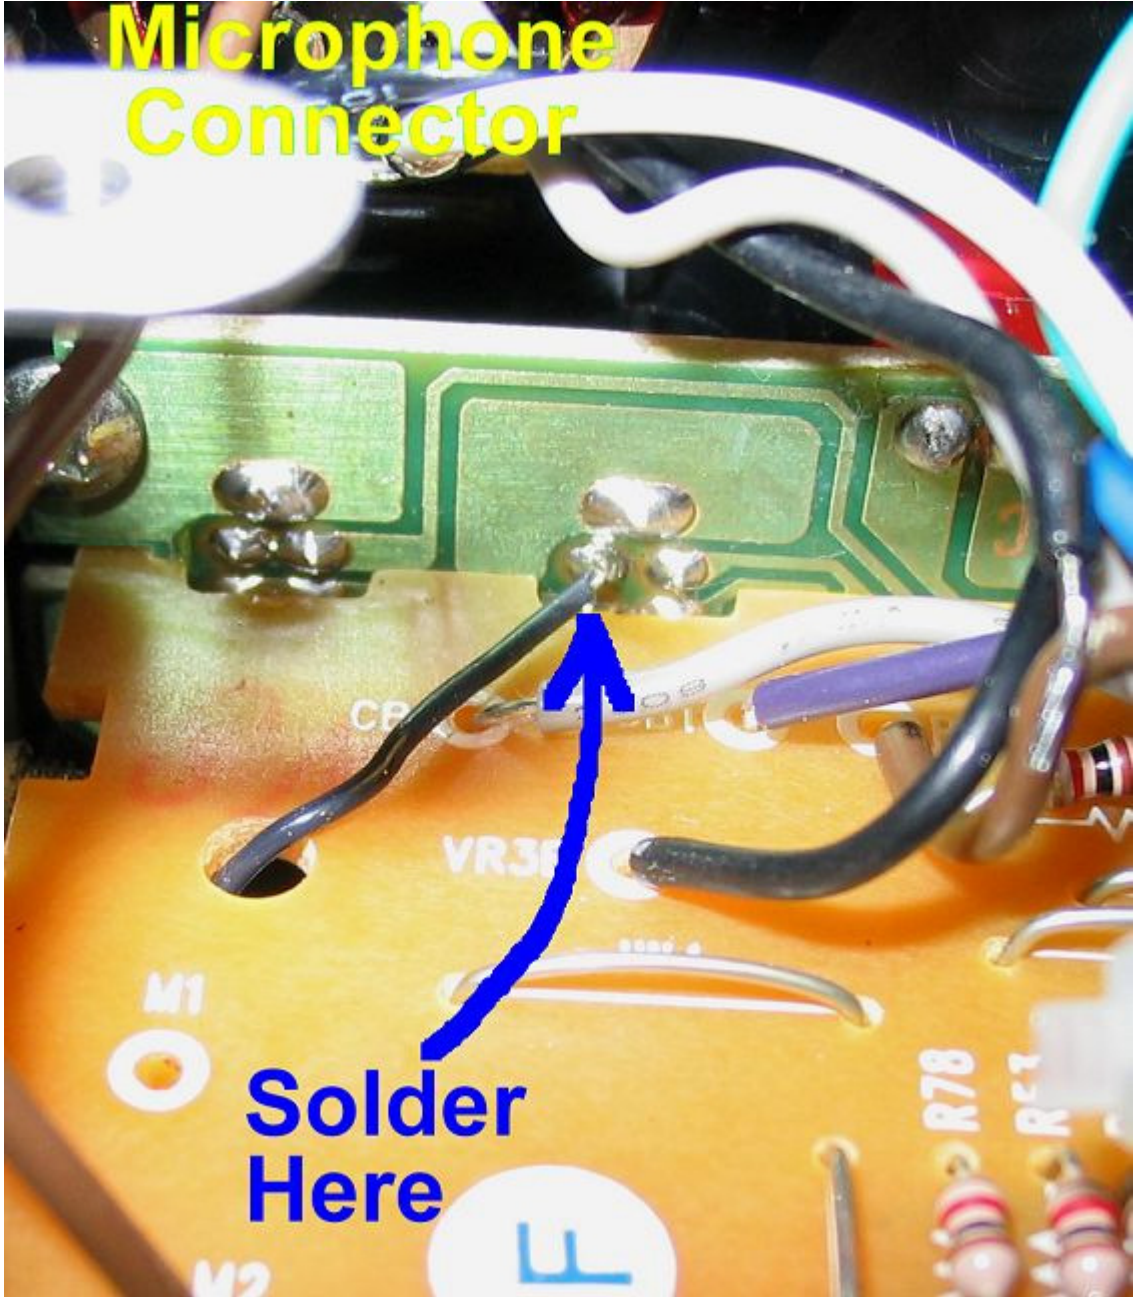
Refer to the pictures on pages 2 and 3.

ACTION: There is too much microphone gain for the PA function, which makes the radio excessively prone to acoustic feedback.

To correct, install a 10K ohm resistor from the open contact on the PA switch to the collector of Q12. Put an insulating sleeve over the resistor.
