COERA 135XLR (TC5080P Divider-NOT PLL!) - UPDATE

COBRA 135XIR (UPDATE)..Cont.

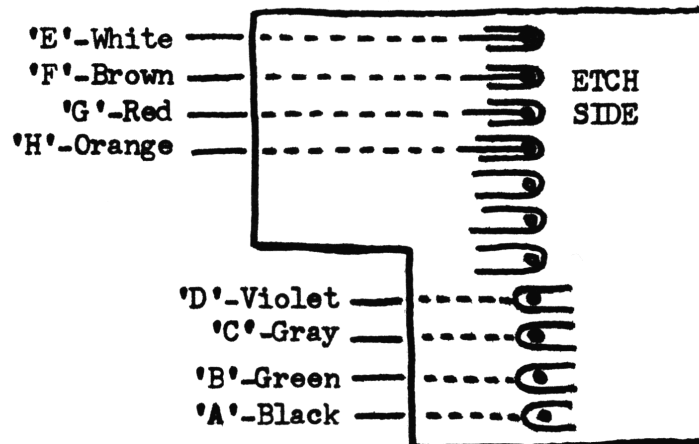
Following is chip, switch modification - follow to the letter.Use the drawing below for Steps 1-4, clean out all holes on push button assy board.....

1. Remove wires: A, B, C, D, E, F, G, and H; from the push-button assy board.
2. Remove wires A, B, and C from other board, solder wire D to where wire C just removed. (Cut to length, as are 'hard-wiring' the PA/CB to permanently CB.).
3. Remove wires E, F, and G from other board, solder wire H to where wire G just removed. (Cut to length, as are 'hard-wiring' the NB/ANL permanently on.)
4. Turn unit on and double-check to see that you wired everything correctly so far.

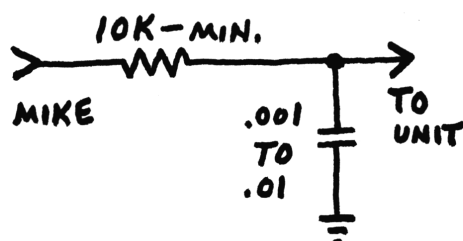
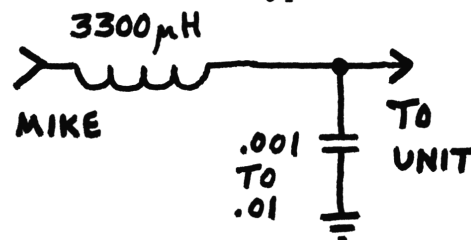
1. Check grounds on Radio, Linear, and Antenna.
2. Check for NO voltage drop to either unit when keyed up.
This is the main cause of squeal. Voltage/Current limiting!
3. Try different lengths of coax between the radio and linear.
4. Take case off radio, check for a small disc capacitor on the audio chip to CASE GROUND. Remove it, and try again.
- This has worked with the Uniden SSB chassis before -
5. The microphone can also be a source of problem. SQUEAL after all is nothing but RF FEEDBACK. To eliminate if microphone is the problem: Go to straight cable, instead of coiled.
In difficult cases an RF filter in the transmitter audio input is needed. Try the following: Ferrite bead on audio input lead, .001MFD from audio input lead to D.C. Ground, or a filter network on the audio input. See below for two different types:
