Craig Model L630 Service Bulletin# 080178

SB: #080178 August 1, 1978

SUBJECT: L630, C.B. Transceiver

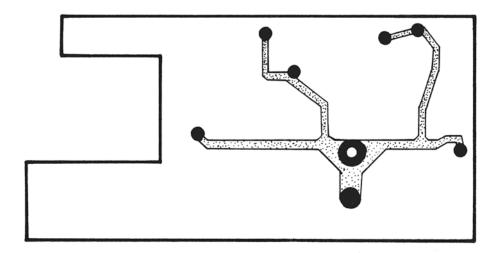
AUDIO P.C.B. (Top View)

- MAY EXHIBIT One or more of the following: low volume, PROBLEMS: oscillation, no audio dim channel display, or may transmit one frequency on all channel positions.
- CAUSE: Problem is due to poor grounding of Audio P.C.B.
- SOLUTION: Resolder ground connections on the audio P.C.B. Traces should be soldered on the <u>component</u> side of the P.C.B. as indicated below.
