Omega Force S45HP and Magnum 257HP Update June 2010

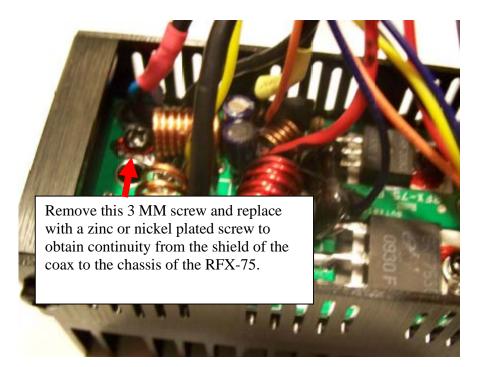
While transmitting the radio "breaks lock" or the CPU malfunctions.

- 1. Unsolder the shield of the coax that is connected to Output side of the RFX-75 where it connects at the radio.
- 2. Verify that there is continuity from the shield of the coax to the Chassis of the RFX-75. You may need to remove one of the screws holding the inspection plates on to the top or bottom of the RFX-75 and install one side of the ohm meter in the screw hole to get a good connection).

3. If there is no continuity, remove the two screws that attach the RFX-75 to the back of the radio to gain access to the component side of the RFX-75. Locate the screw shown in the picture below, and replace it with a zinc or nickel plated 3MM screw. This will make the connection needed from the Coax Shield to Chassis Ground
