Installation of Kit 89-1 in JC Penny 981-6237

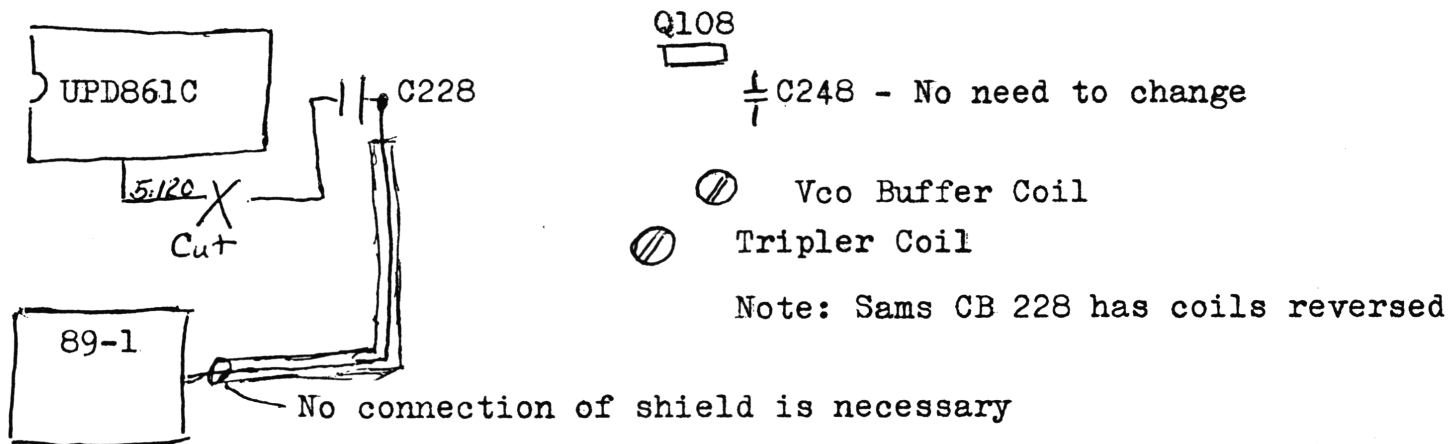
When this kit was installed according to instructions it would not work. Reread instructions and rechecked connections, everything was right but still no frequencies. After adjusting got the High frequencies but no Lows and lost the normal 40.

Had to experiment but found the right spot to hook in to. The kit may not lock-in all frequencies as the VCO has a limited range.

See hook up below.

No need to adjust tripler coil, it works just fine.

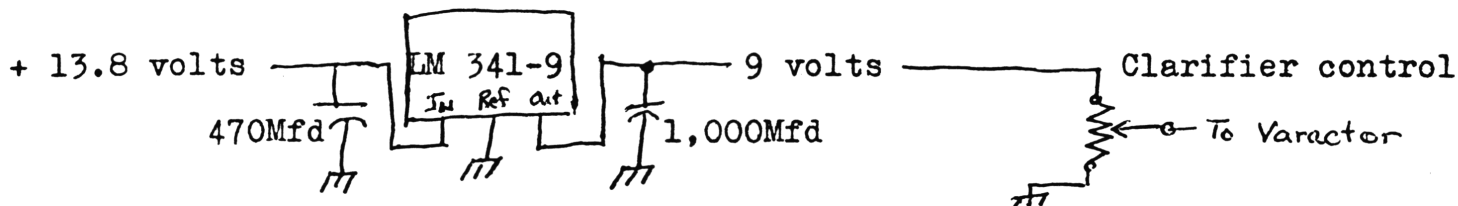
Clarifier Voltage regulation in all radioes.

Still have a radio that shifts between receive and transmitt?
Try the following circuit. It has cured quite a few problems for me.

This regulated voltage does not drop even .1 volts when the radio is in the transmitt mode.
